Baltimore County
Department of Environmental Protection & Sustainability

**DULANEY VALLEY BRANCH
AT WINDEMERE
STREAM RESTORATION PROJECT**

October 24, 2017

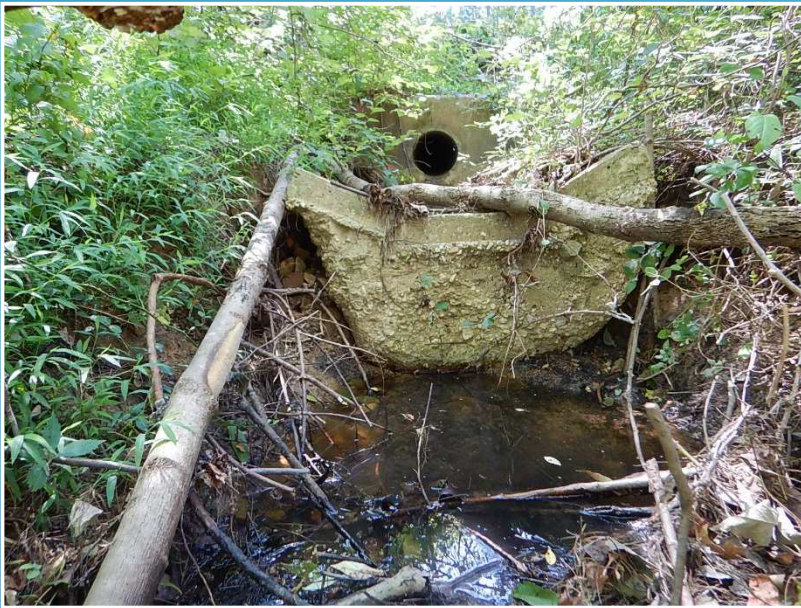
- ▶ Channel conditions – Unstable storm drain infrastructure

Undercut storm drain outfall at Siesta Garth

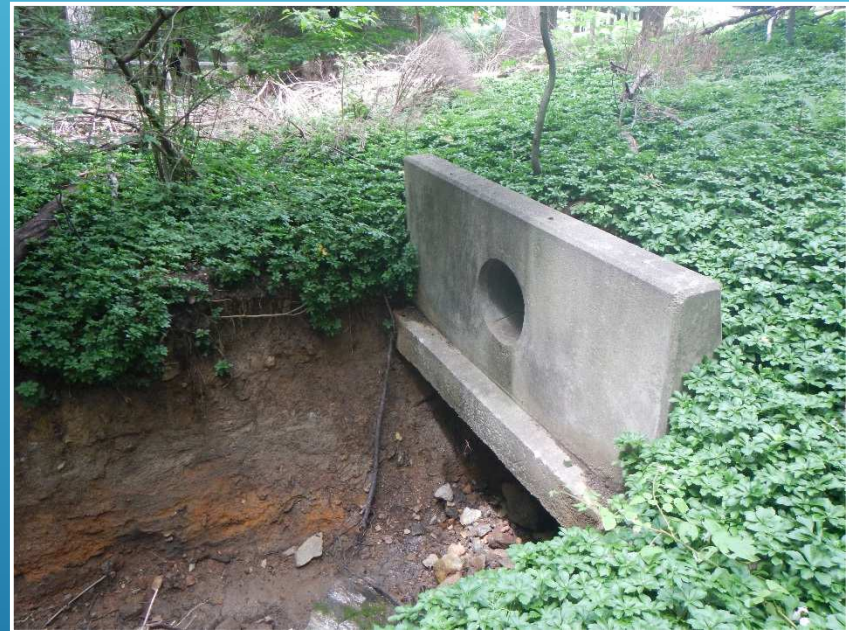
Severe down-cutting at storm drain headwall

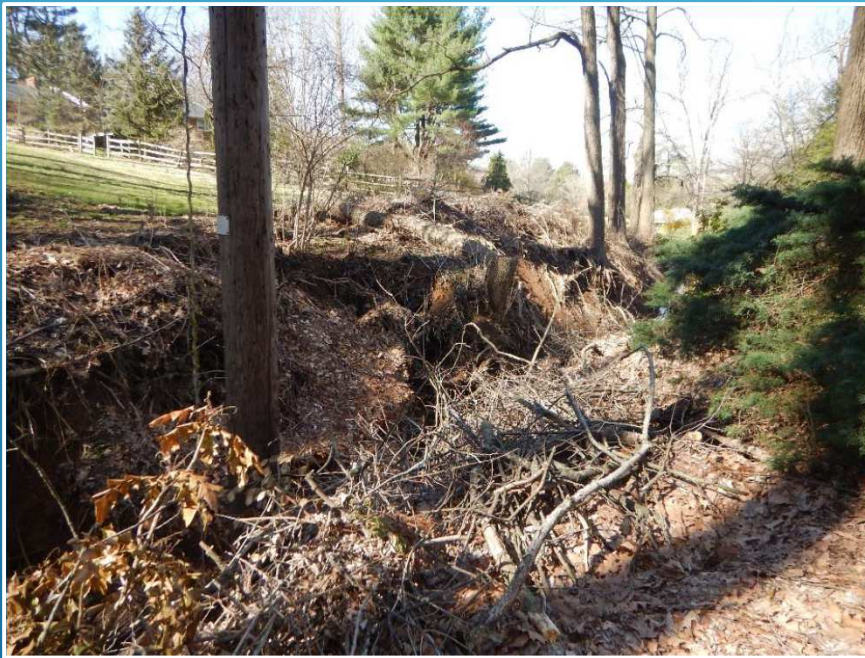
- ▶ Channel conditions – exposed/threatened utility poles

Pole exposed within eroded channel

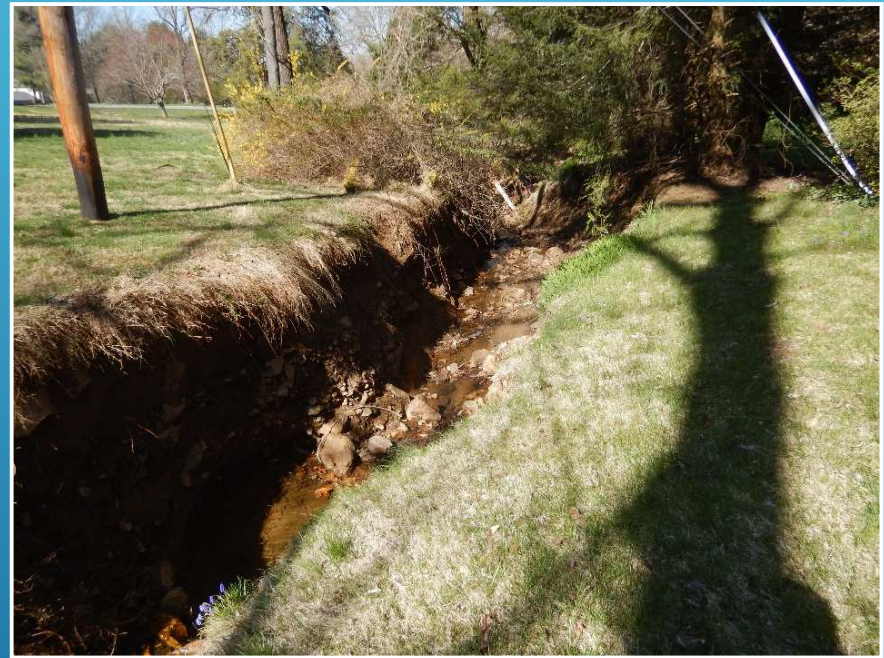
Pole within close proximity of actively eroding channel

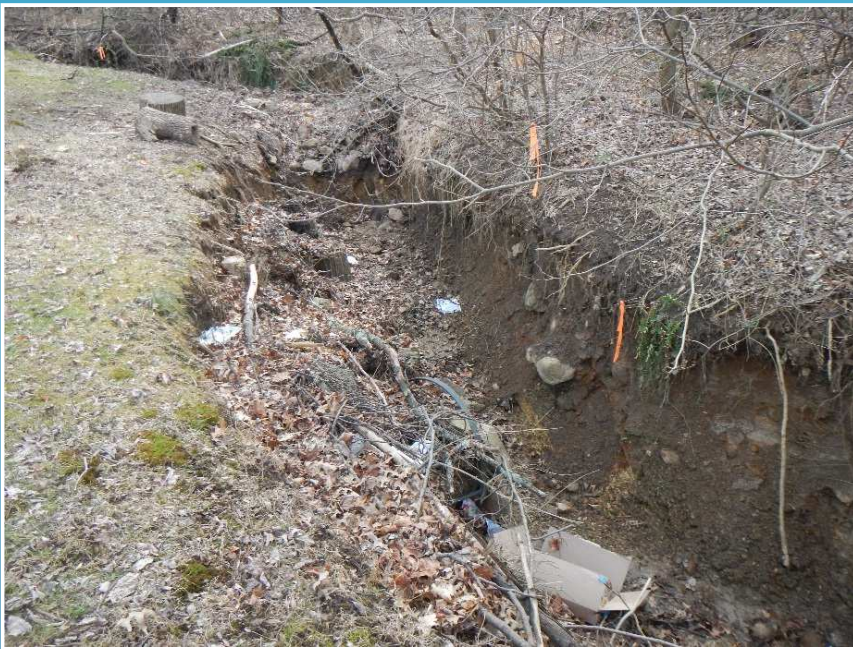
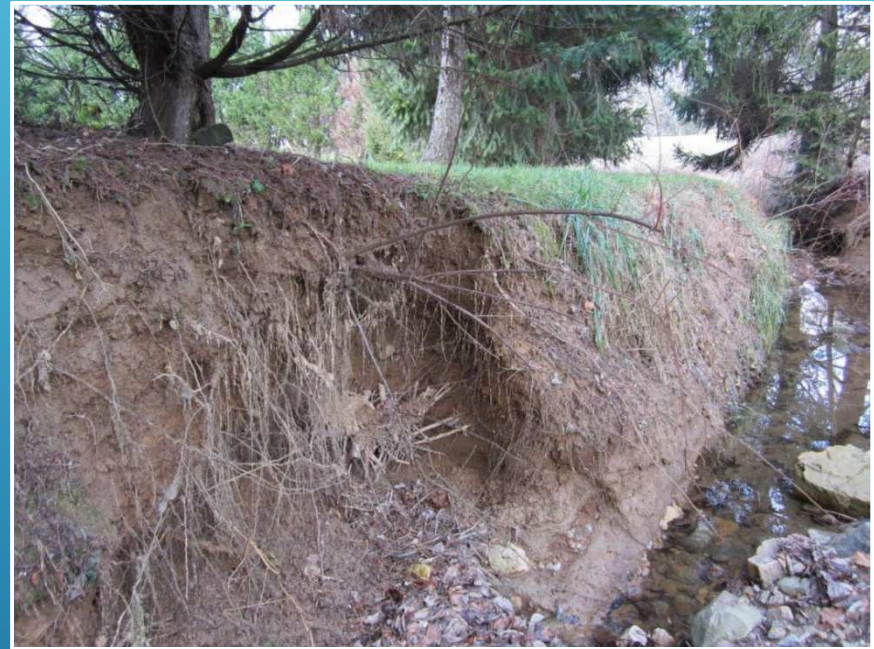
▶ Channel conditions – Significant erosion

The channel has incised to a degree that larger storm events remain constricted within the stream banks. This increases shear stress on the banks and erodes the streambed, furthering stream degradation.

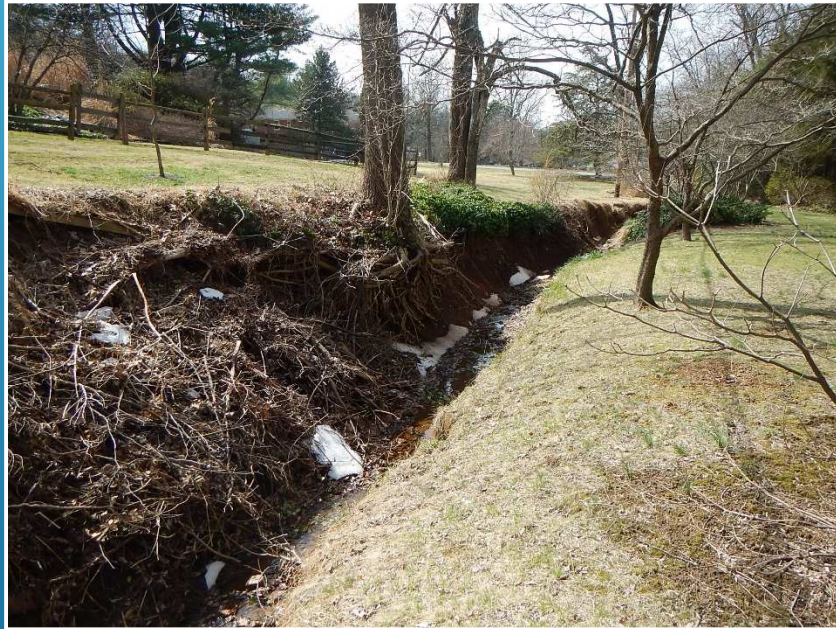
- ▶ Channel conditions – Poor riparian buffers

Lack of vegetated riparian area, mowing to edge of bank
